Our Ref: **TRELF87704**

3000mm x 1100mm Panoramic Frameless Glass Juliet Balcony

BS 6180:2011: Barriers in and about buildings – Code of practice  
- Domestic applications (ii) – Clause 6.4.1

# TECHNICAL REPORT

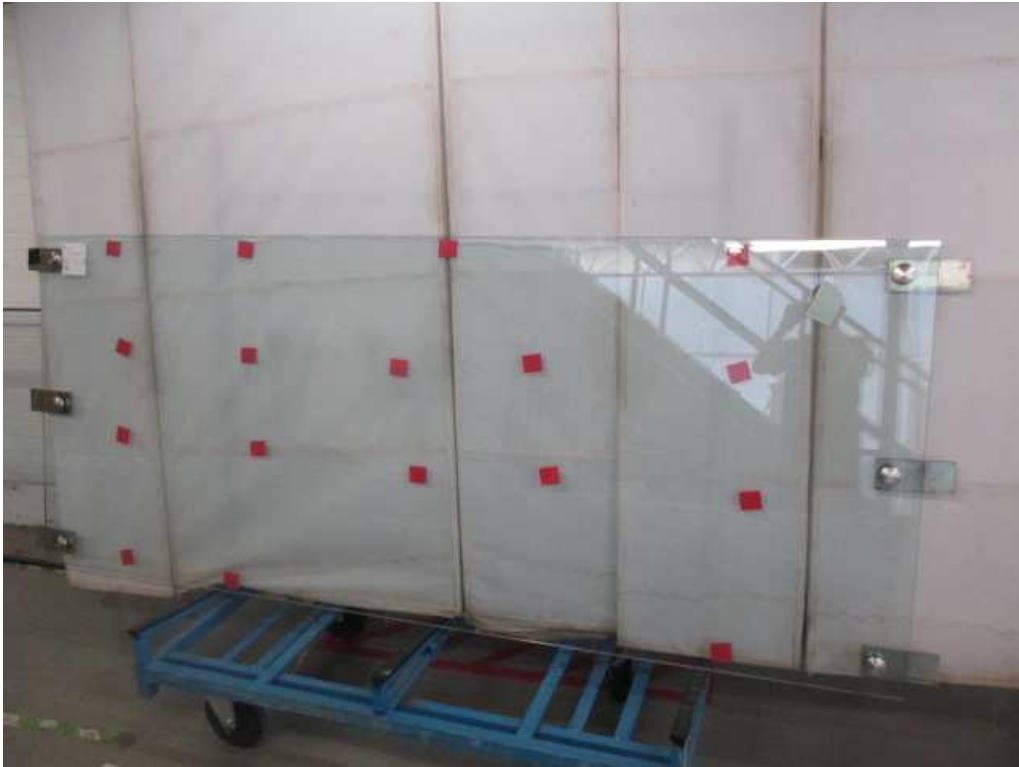
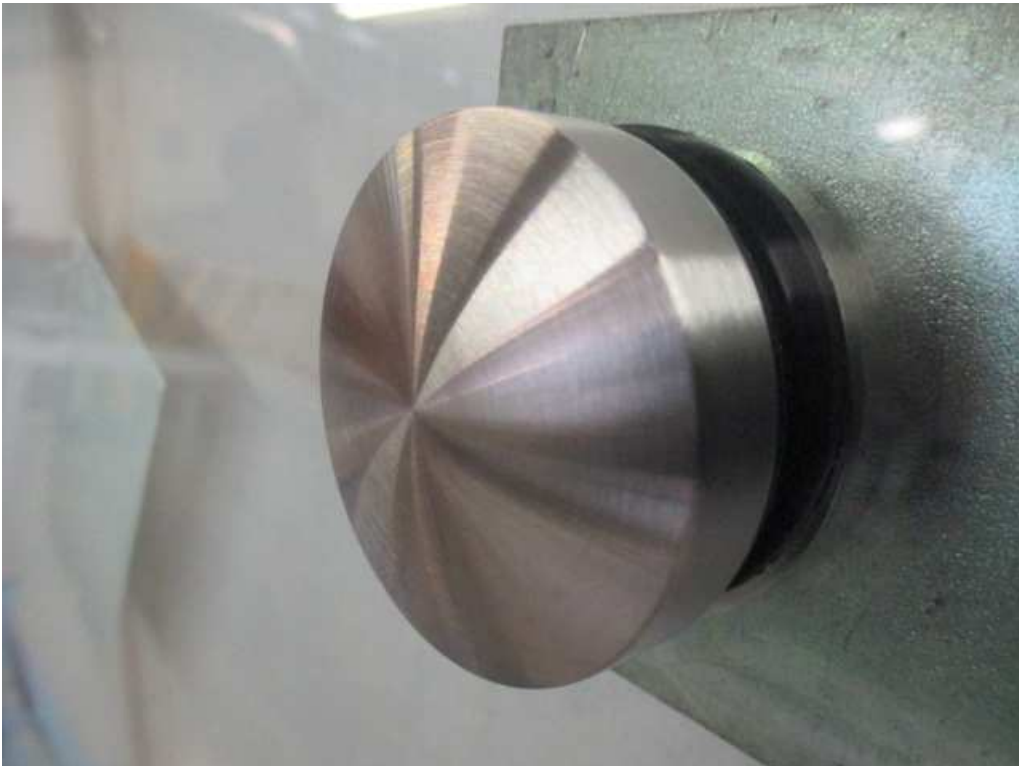
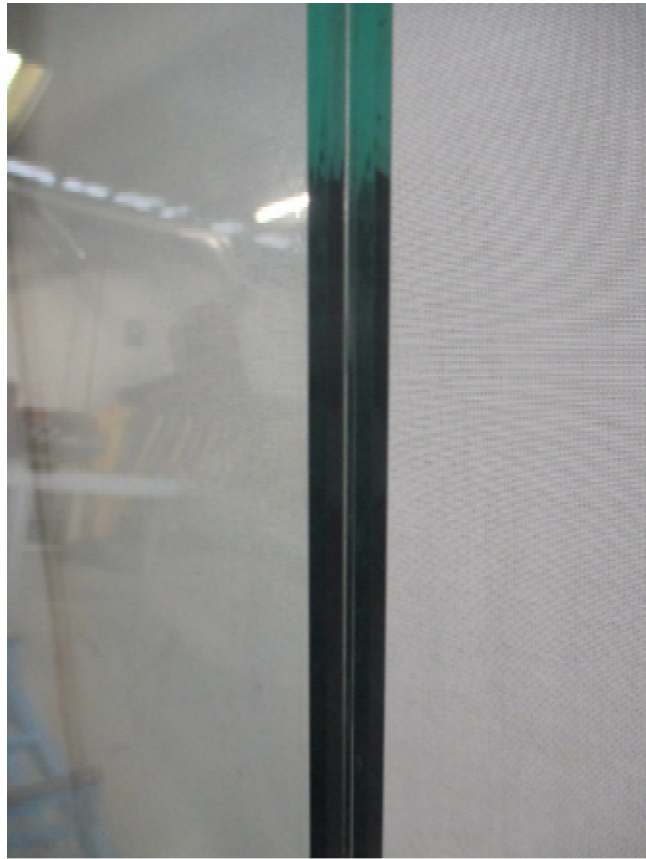
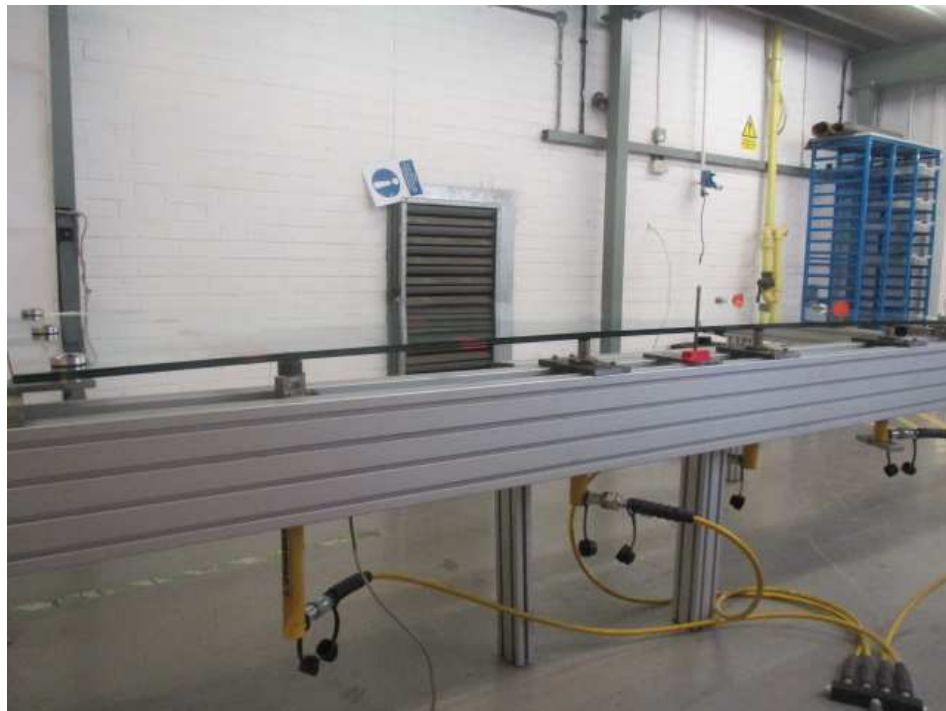
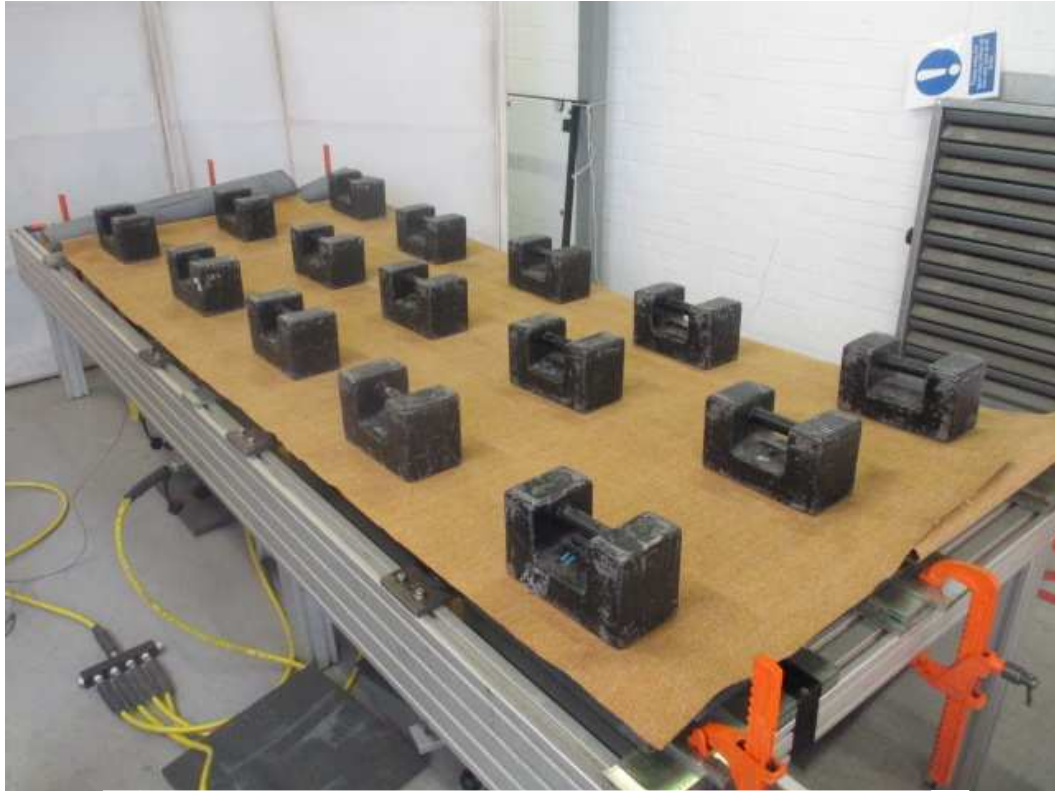
Panoramic Frameless Juliet Balcony unit with 2 piece metal wall clamp brackets. 3000mm x 1100mm toughened glass panel infill.

Plate 1: 3000mm x 1100mm Panoramic Frameless Juliet Balcony

Plate 2: 3000mm x 1100mm Panoramic Frameless Juliet Balcony

Plate 3: 3000mm x 1100mm Panoramic Frameless Juliet Balcony

Plate 4: 3000mm x 1100mm Panoramic Frameless Juliet Balcony

Plate 5: 3000mm x 1100mm Panoramic Frameless Juliet Balcony

The horizontal balustrade is laid horizontally and mounted in a universal test rig with both ends fully supported by and clamped to Aluminium channel sections.

Test Requirements		Result – Domestic level (ii)
Handrail stiffness	Design load	Initial loading	60mm
		Deflection	Pass – 25mm
Handrail strength	BS 5268-2:2002	Initial loading	Not required
		After 15 mins	Not required
In-fill strength	Design load	Initial loading	Pass – 297Kg
Strength of Balusters		Initial loading	N/A
