Our Ref: **TRELF87705**

3000mm x 1100mm Alaska Glass Juliet Balcony

BS 6180:2011: Barriers in and about buildings – Code of practice
- Domestic applications (ii) – Clause 6.4.1

TECHNICAL REPORT

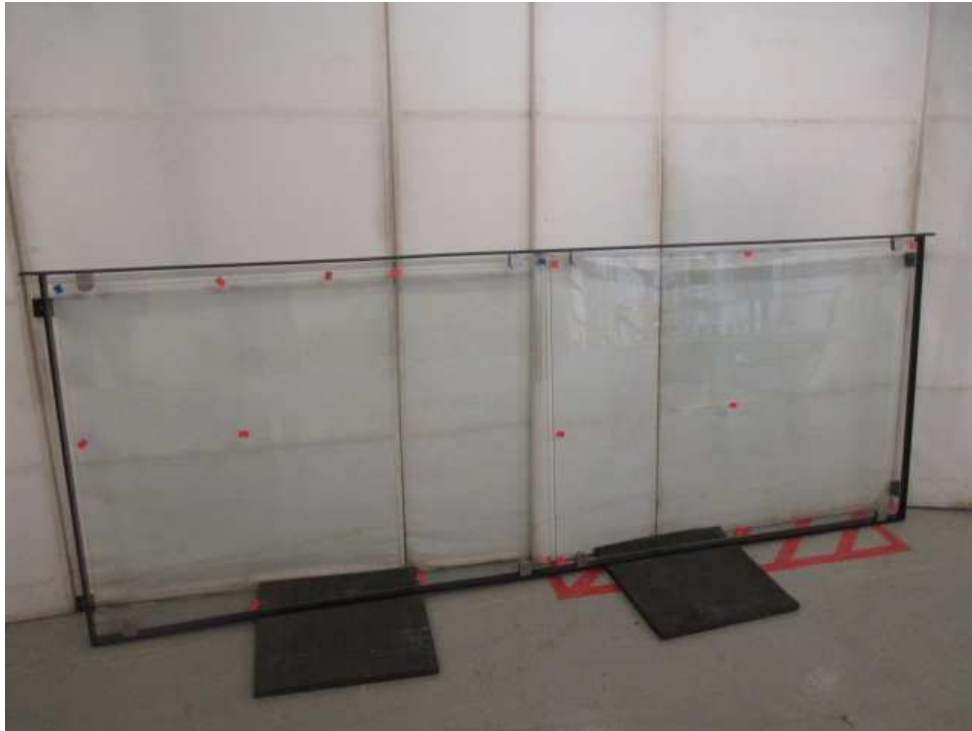
Plate 1: 3000mm x 1100mm Alaska Glass Juliet Balcony

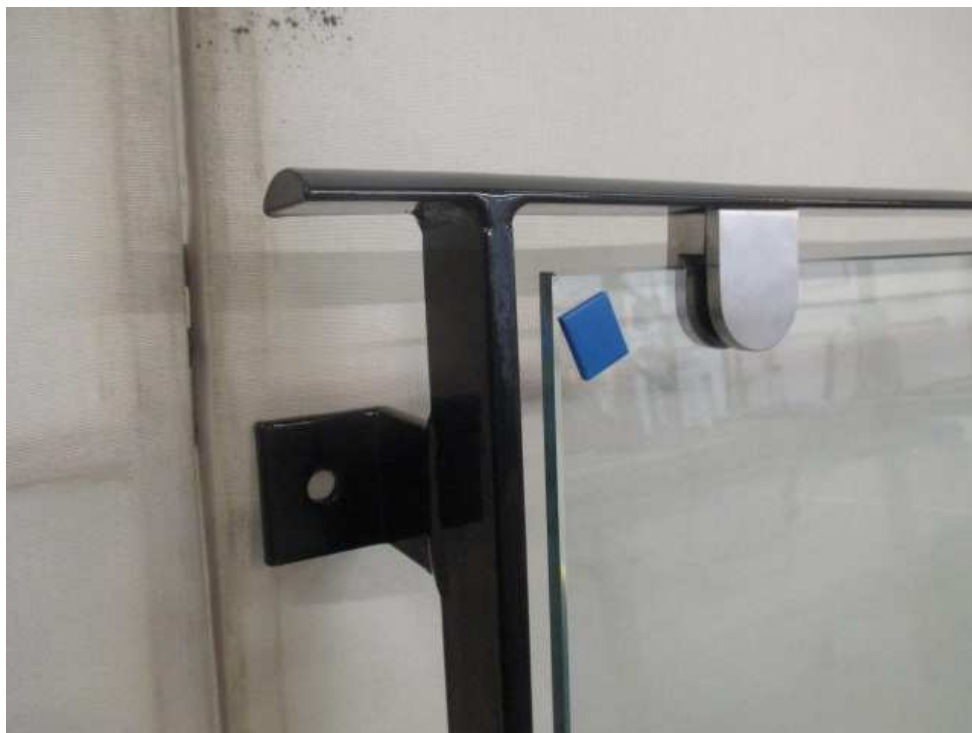
Plate 2: 3000mm x 1100mm Alaska Glass Juliet Balcony

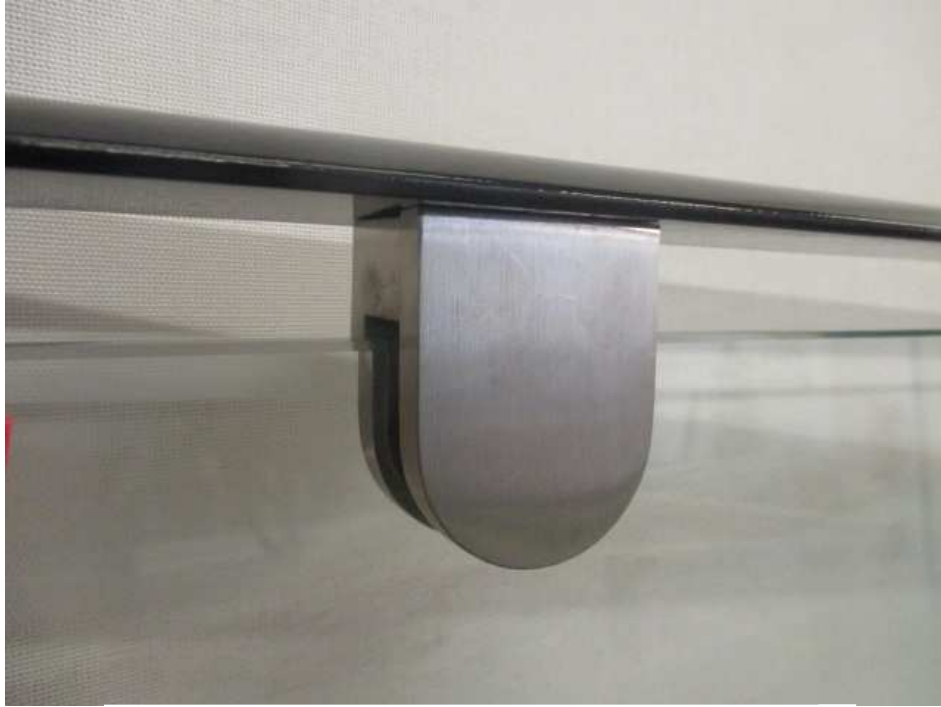
Plate 3: 3000mm x 1100mm Alaska Glass Juliet Balcony

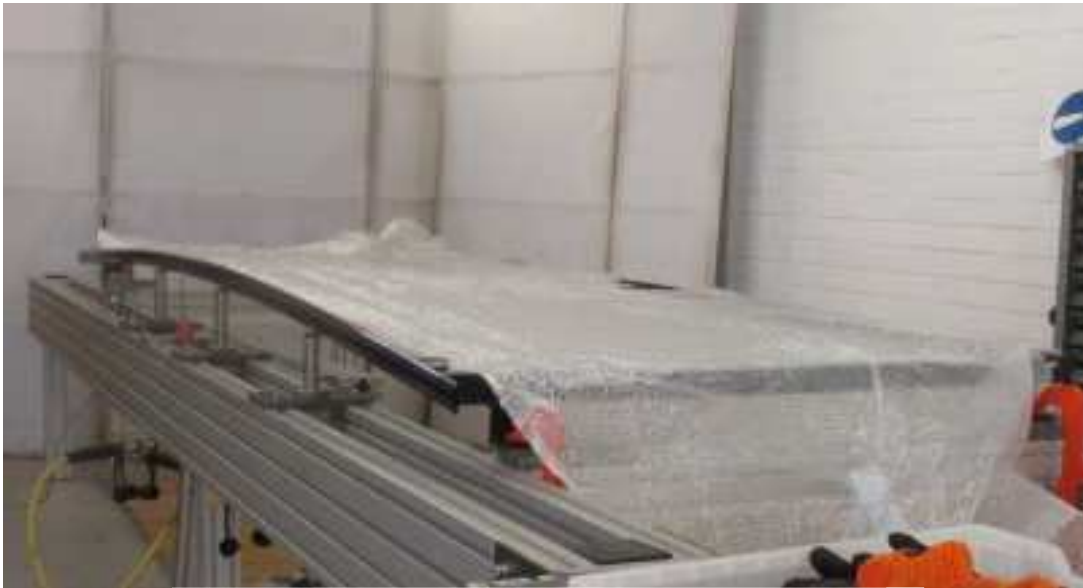
Plate 4: 3000mm x 1100mm Alaska Glass Juliet Balcony

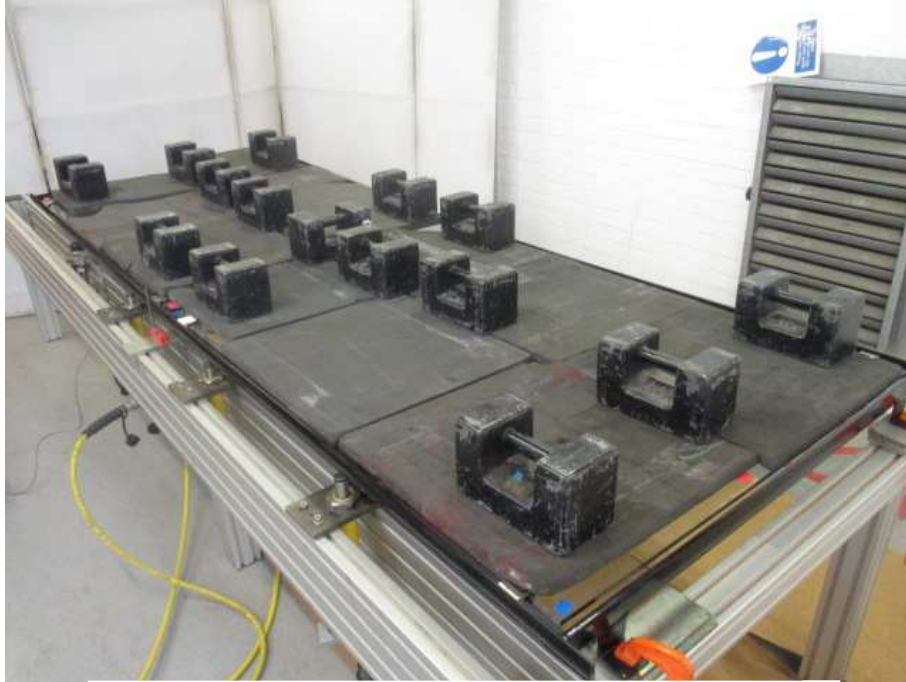
Plate 5: 3000mm x 1100mm Alaska Glass Juliet Balcony
